| 1. CASE NO. 930629CCCC1442 | | 2. INVESTIGATOR'S ID <div style="border: 1px solid black; padding: 2px; display: inline-block;">8 2 3 2</div> | | 3. OFFICE CODE <div style="border: 1px solid black; padding: 2px; display: inline-block;">8 7 0</div> | | <h2 style="margin: 0;">EPIDEMIOLOGIC INVESTIGATION REPORT</h2> | |
| 6. SYNOPSIS OF ACCIDENT OR COMPLAINT A toaster oven apparently ignited itself while the owners were away from home. The toaster oven was reported to have been turned off and not in use at the time. One of the owners returned and found the fire smoldering. The fire was confined to the area of the appliance. No injuries were reported. An independent forensic engineer attributed the fire to a defective control circuit component inside the toaster oven. | | | | | | | |
| 10A. FIRST PRODUCT Toaster Oven | | | 11A. TRADE/BRAND NAME, MODEL NUMBER, MANUFACTURER & ADDRESS Model: TRO 200 Black & Decker Inc., Shelton CT 06484 | | | | |

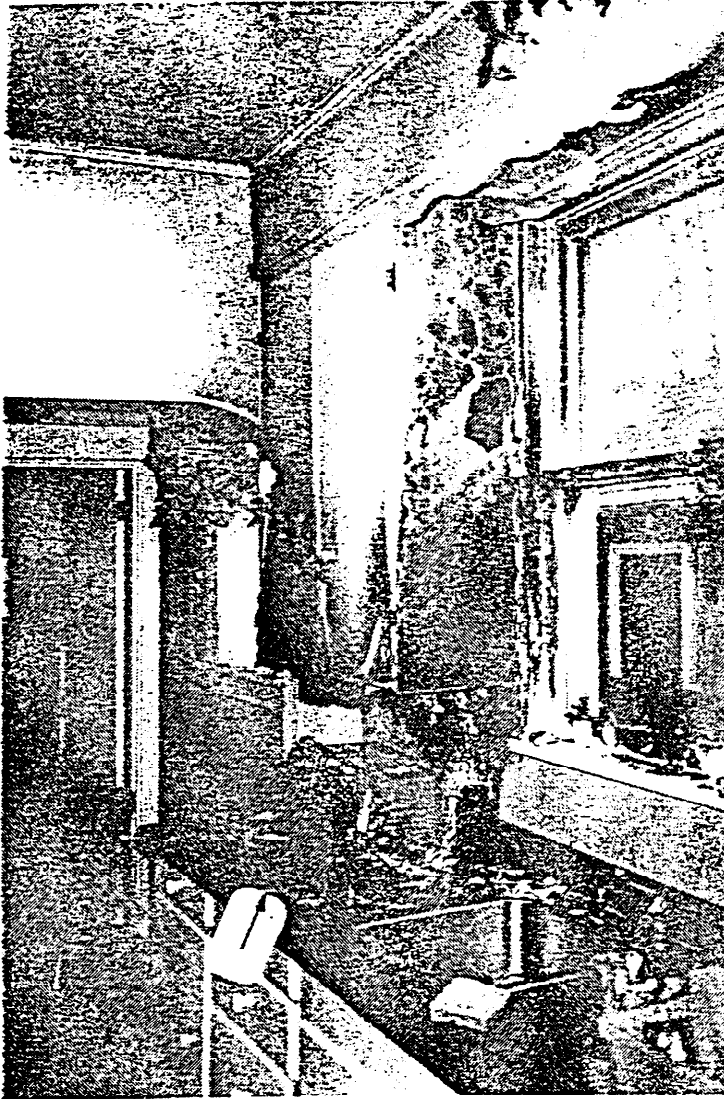
FIGURE 2

- b. The toaster oven was located in the center of the fire-damaged area oriented such that the right side of the oven was in line with the area of lowest burning observed on the wall behind the oven (fig. 2).

- d. The toaster was plugged into a wall socket to the left of the oven. The wall socket suffered no fire damage (fig. 1, arrow).
 - e. Located near the right front corner of the oven was a small pile of fire-damaged debris. It was reported by Mr. Hardiman that this debris was probably the remains of a pair of jeans lying on the counter (fig. 2, arrow).

- f. The oven was the only electrical appliance plugged in or located within the area of origin as shown in Figures 1 and 2.
 - g. A small jar was observed against the splash board of the counter, to the right of the oven, reportedly containing sun-dried tomatoes.

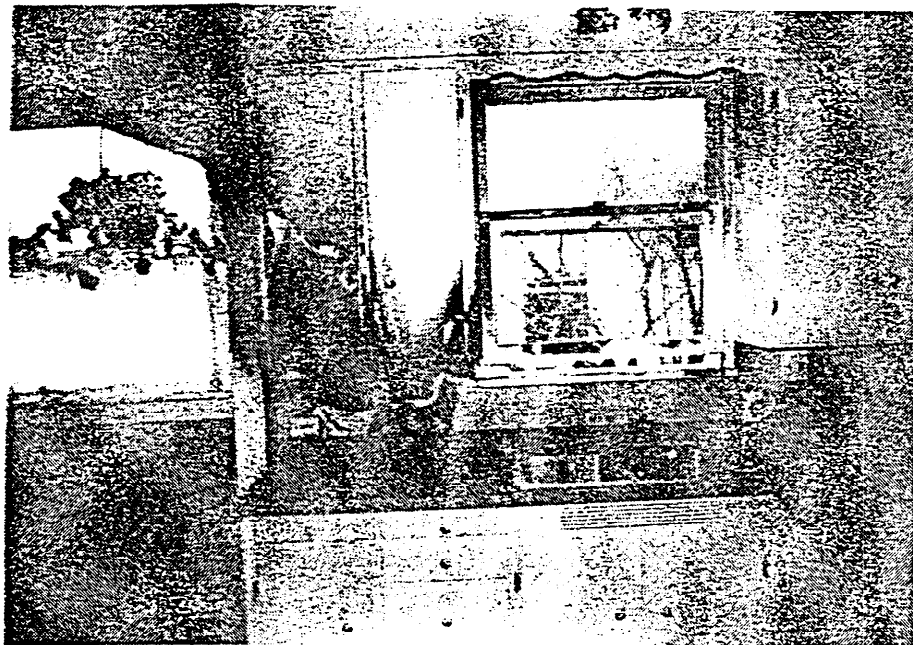
FIGURE 3

- c. The wooden splash board at the back of the counter was charred for a distance nearly equal to the length of the back of the oven and extended down to the counter (fig. 3).

2. The first material ignited was probably the wooden splash board at the back of the counter. The width of the char pattern is consistent with ignition of the wood as a result of heat from the back of the oven. Tests indicate that normal operation of the oven would not ignite the wood and, therefore, it is likely that an overheating condition existed. Also, the molded sides of the oven have protuberances extending out from the back surface that do not allow the oven to be placed directly against a wall, promoting air flow and further minimizing the chance of igniting combustible wall materials during normal operation.

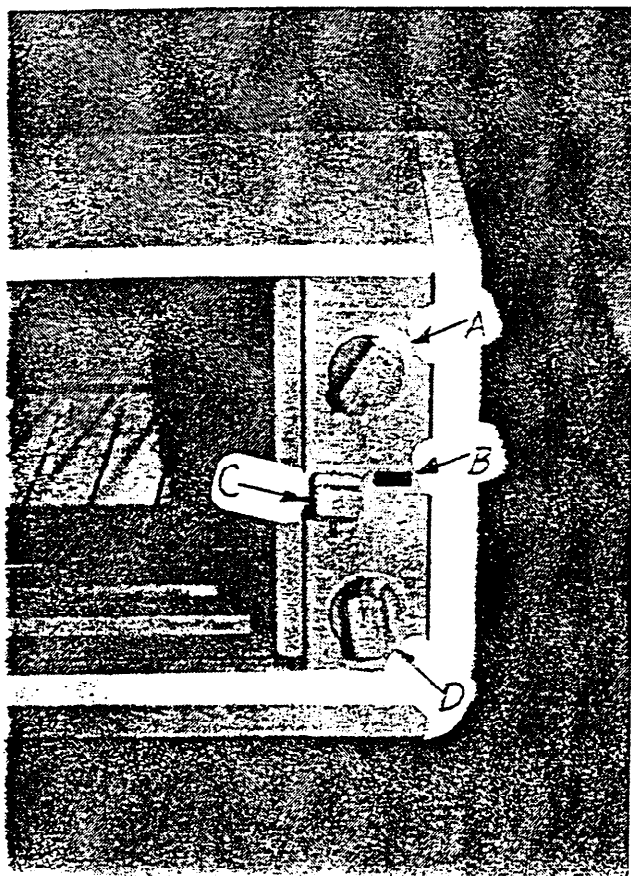
FIGURE 4

4. Operation of the toaster oven (ref. figs. 4 & 5):
- a. The upper control knob (arrow A) is used for baking and heating. Both sets of two upper and two lower elements cycle on and off to maintain the selected temperature.

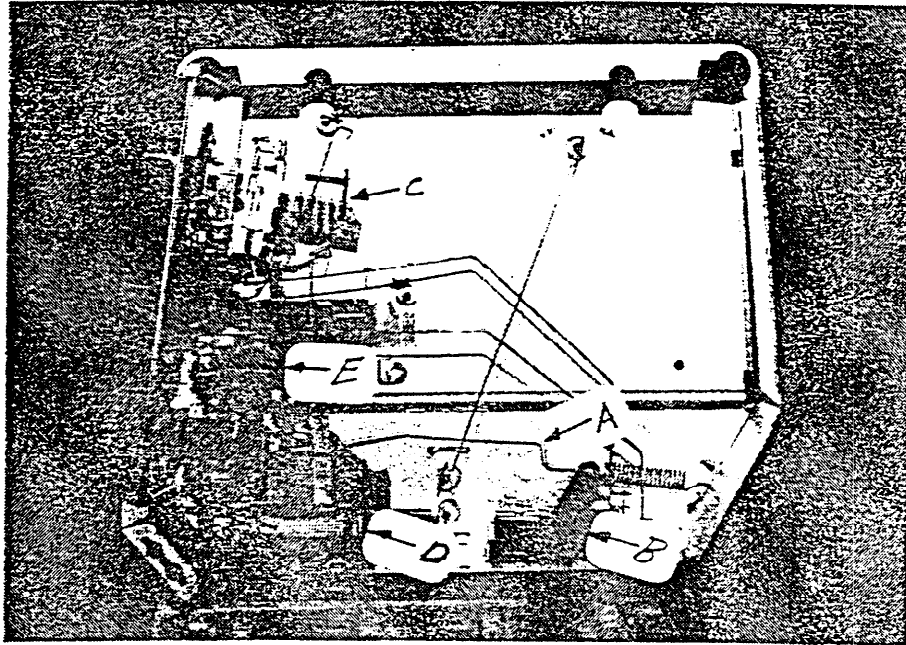
FIGURE 5

- e. The oven (and toaster) will shut off whenever the door is opened. A link between the door and a set of contacts causes the contacts to open, de-energizing the oven. Figure 5, arrow A, shows the link, and arrow B shows the contact set.

- g. The toast cycle is terminated when, due to a closing of contacts caused by a heating element, arrow D, the solenoid coil, arrow E, is energized. The plunger in the solenoid pushes the toaster lever, allowing it to move upwards and open its contacts. When this occurs, the solenoid coil is de-energized.

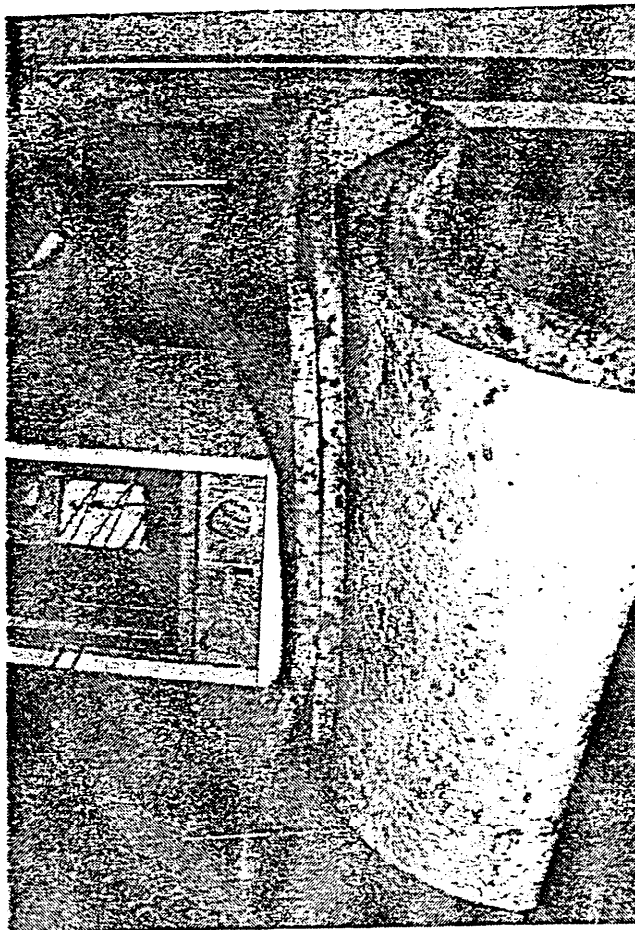
FIGURE 9

A second test was run in which fiberglass insulation was placed over the temperature probe on the side and the whole side was covered with approximately 2" of foam rubber (fig. 9). The oven was set to its maximum setting, and temperatures in the oven, its top, the right side, and the back were recorded over a period of 1 hour and 7 minutes. The results of this test indicate the top reached a maximum temperature of 385° F. while the side reached a maximum of 242° and the back reached a maximum of 290° F.
